**Flood Control Project Maintenance
Levee Inspections**

Maintenance Issue Types Only, Levee Inspection Report By Mile - Spring 2015

Reclamation District No. 1001 Nicolaus

Waterway	Bank	Unit Miles	Inspection Start/End	Inspector
Unit No. 01 Yankee Slough	Right	4.12	05/18/2015 05/18/2015	Michael Pitta

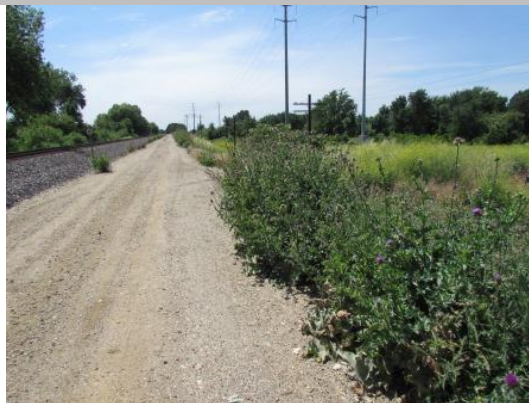
Photo 1 of 1 : SP_2015_RD1001_36_8_20150521_00008.jpg

LM Start	0.33	Rating **	M	Issue No.	8
LM End	4.10	Issue Type +	Ma	Location *	WS
Category	Earthen Levee			GPS Latitude/Longitude	
				Start	End
Item	Vegetation			38.976715 °	38.970518 °
				-121.473997 °	-121.534452 °
DWR ID	DWR_RD1001_01_s _ 2015_8				
Action/Comments					
Control annual grass and weeds on the levee slopes and easements.

View of the vegetation on the waterside of the levee facing downstream.

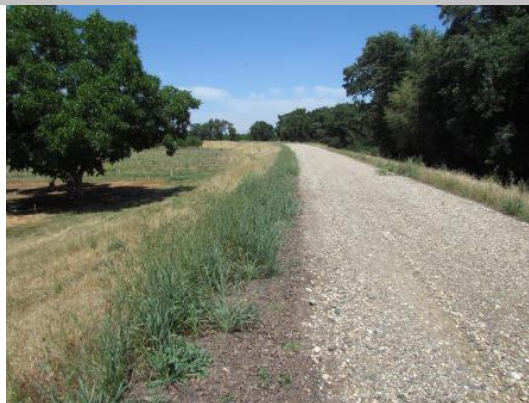
Photo 1 of 1 : SP_2015_RD1001_35_5_20150521_00011.jpg

View of the vegetatin on the landside of the levee facing downstream.

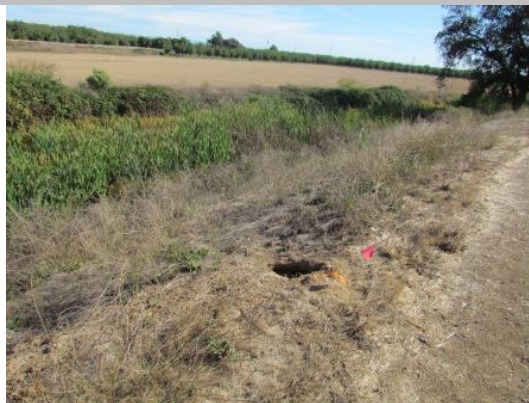
Photo 1 of 2 : SP_2015_RD1001_35_4_20150401_00001.jpg

This photo was taken from the levee crown facing east looking down the waterward slope at an animal burrow. Fall 2014.

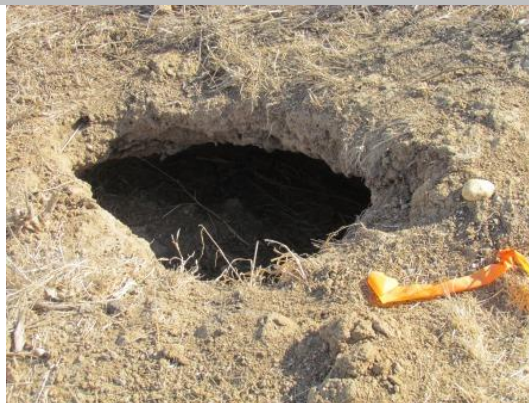
Photo 2 of 2 : SP_2015_RD1001_35_4_20150401_00002.jpg

Another picture of the animal burrow. Fall 2014.

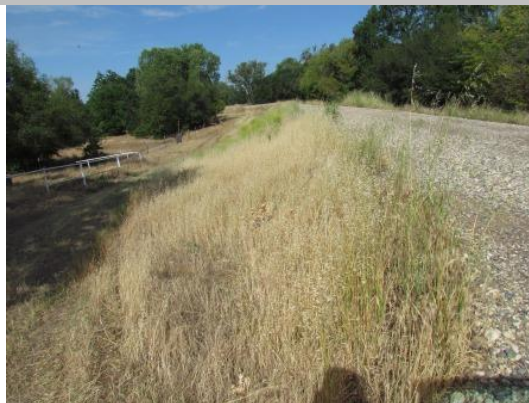
Photo 1 of 1 : SP_2015_RD1001_37_6_20150521_00033.jpg

View of the vegetation on the landside of the levee facing downstream.

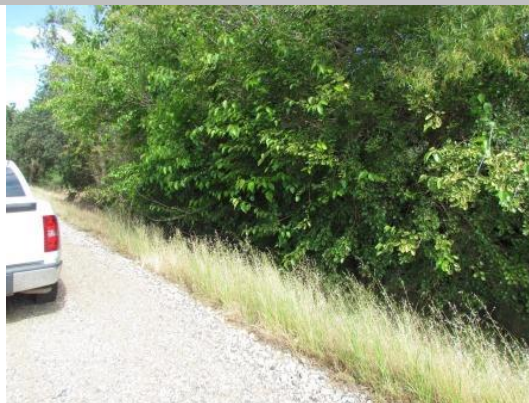
Photo 1 of 1 : SP_2015_RD1001_37_14_20150521_00034.jpg

View of the trees on the waterside of the levee facing downstream.

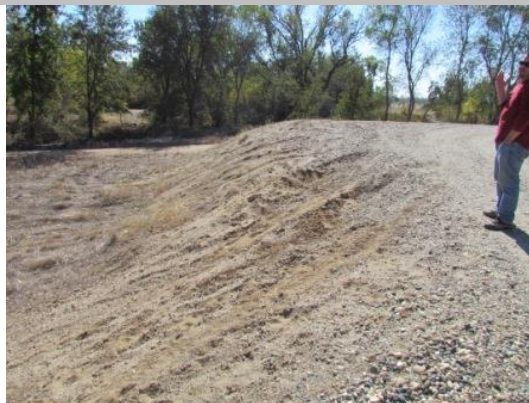
Photo 1 of 2 : SP_2015_RD1001_37_2_20150401_00002.jpg

LM Start	0.11	Rating **	M	Issue No.	2
LM End	0.11	Issue Type +	Ma	Location *	CR
Category	Earthen Levee			GPS Latitude/Longitude	
				Start	End
Item	Slope Stability			39.006569 °	39.006569 °
				-121.377037 °	-121.377037 °
DWR ID	DWR_RD1001_03_f_2013_2				
Action/Comments					
Repair the levee slope damaged by vehicle traffic and prevent access where possible.					
Inspector Comments: Rutting caused by vehicles driving up the landward levee slope.

This photo was taken from the crown of the levee facing west looking down the slope at rutting caused by vehicles driving up the landward levee slope.

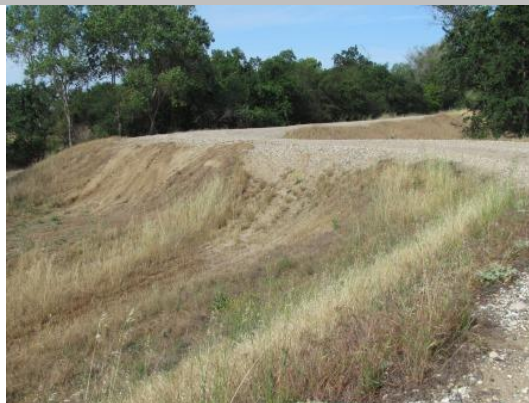
Photo 2 of 2 : SP_2015_RD1001_37_2_20150521_00035.jpg

View of the rutting on the landside of the levee facing upstream.

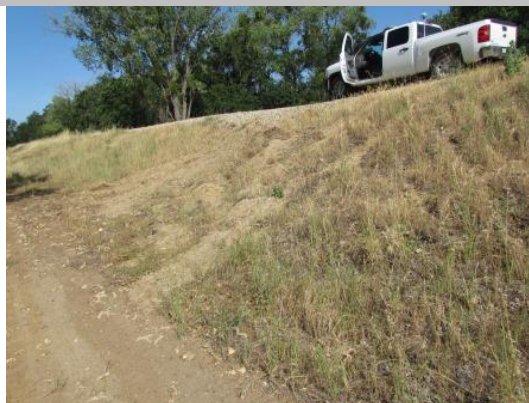
Photo 1 of 1 : SP_2015_RD1001_37_23_20150521_00036.jpg

LM Start	0.14	Rating **	M	Issue No.	23
LM End	0.14	Issue Type +	Ma	Location *	LS
Category	Earthen Levee			GPS Latitude/Longitude	
				Start	End
Item	Slope Stability			39.006351 °	39.006351 °
				-121.377313 °	-121.377313 °
DWR ID	DWR_RD1001_03_s_2015_23				
Action/Comments					
Repair the levee slope damaged by vehicle traffic and prevent access where possible.

View of the rutting on the landside of the levee from the toe facing downstream.

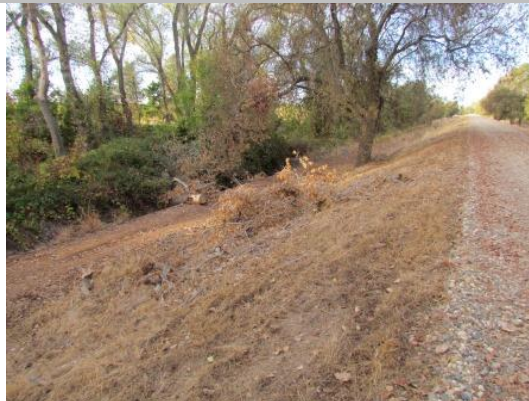
Photo 1 of 1 : SP_2015_RD1001_37_18_20150401_00010.jpg

This photo was taken from the levee crown facing west looking down the landward slope at a fallen tree that needs to be removed. Fall 2014.

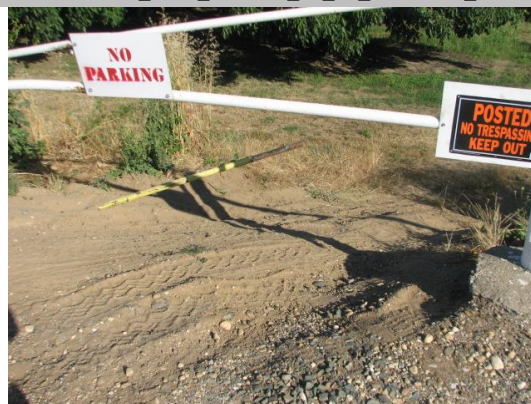
Photo 1 of 2 : SP_2015_RD1001_37_28_20150401_00017.jpg

LM Start	1.87	Rating **	A/W	Issue No.	28
LM End	1.87	Issue Type +	Ma	Location *	WS
Category	Earthen Levee			GPS Latitude/Longitude	
				Start	End
Item	Slope Stability			38.998608 °	38.998608 °
				-121.405570 °	-121.405570 °
DWR ID	DWR_RD1001_03_s_2013_28				
Action/Comments					
Repair the levee slope damaged by vehicle traffic and prevent access where possible.

Damage caused by vehicles Spring 2013

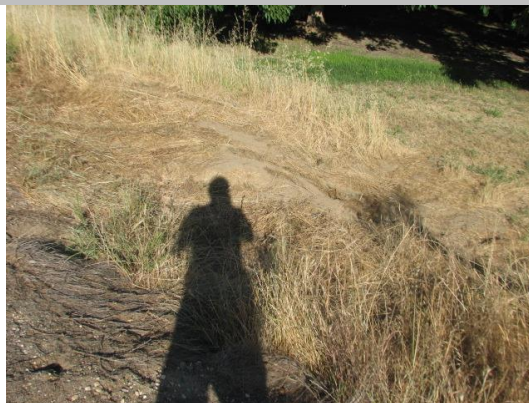
Photo 2 of 2 : SP_2015_RD1001_37_28_20150401_00018.jpg

LM Start	1.87	Rating **	A/W	Issue No.	28 (cont)
LM End	1.87	Issue Type +	Ma	Location *	WS
Category	Earthen Levee			GPS Latitude/Longitude	
				Start	End
Item	Slope Stability			38.998608 °	38.998608 °
				-121.405570 °	-121.405570 °
DWR ID	DWR_RD1001_03_s_2013_28				
Action/Comments					
Repair the levee slope damaged by vehicle traffic and prevent access where possible.

Damage caused by vehicles. Spring 2013

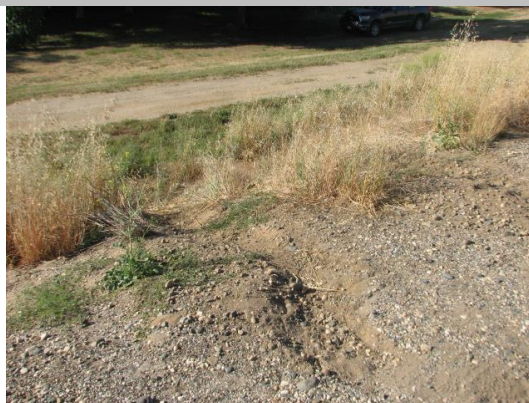
Photo 1 of 2 : SP_2015_RD1001_37_29_20150401_00019.jpg

LM Start	1.87	Rating **	A/W	Issue No.	29
LM End	1.87	Issue Type +	Ma	Location *	LS
Category	Earthen Levee			GPS Latitude/Longitude	
				Start	End
Item	Slope Stability			38.998608 °	38.998608 °
				-121.405570 °	-121.405570 °
DWR ID	DWR_RD1001_03_s_2013_29				
Action/Comments					
Repair the levee slope damaged by vehicle traffic and prevent access where possible.

Damage caused by vehicles going around the gate. Spring 2013

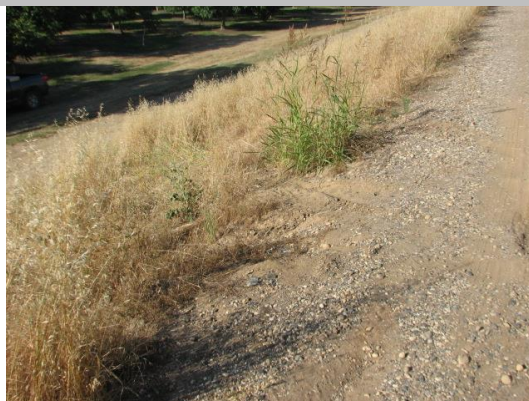
Photo 2 of 2 : SP_2015_RD1001_37_29_20150401_00020.jpg

Damage caused by vehicles. Spring 2013

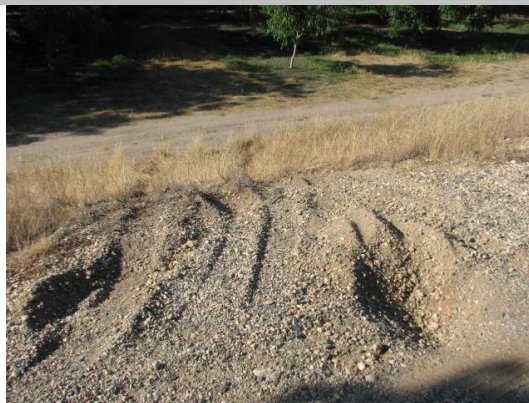
Photo 1 of 1 : SP_2015_RD1001_37_30_20150401_00021.jpg

LM Start	2.28	Rating **	A/W	Issue No.	30
LM End	2.28	Issue Type +	Ma	Location *	LS
Category	Earthen Levee			GPS Latitude/Longitude	
				Start	End
Item	Slope Stability			38.996302 °	38.996302 °
				-121.412285 °	-121.412285 °
DWR ID	DWR_RD1001_03_s _ 2013_30				
Action/Comments					
Repair the levee slope damaged by vehicle traffic and prevent access where possible.

Damage caused by vehicles. Spring 2013

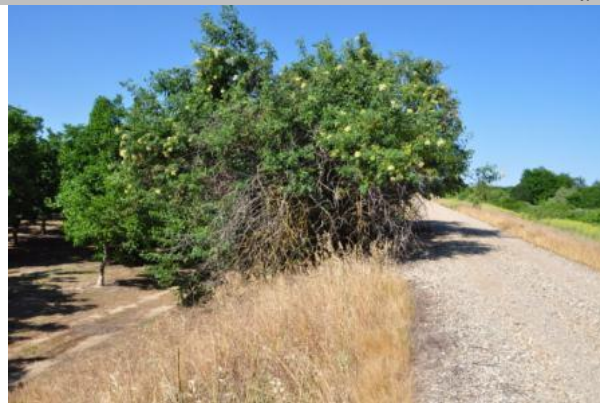
Photo 1 of 1 : SP_2015_RD1001_37_910_20150401_00031.jpg

RD 1001 Unit 3 - L/S slope -Elderberries

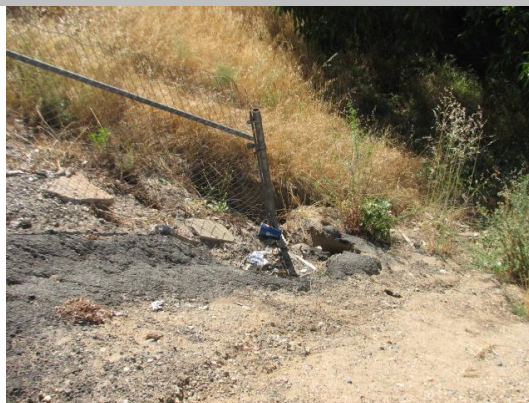
Photo 1 of 1 : SP_2015_RD1001_37_38_20150401_00025.jpg

LM Start	6.47	Rating **	M	Issue No.	38
LM End	6.51	Issue Type +	Ma	Location *	LS
Category	Earthen Levee			GPS Latitude/Longitude	
				Start	End
Item	Erosion / Bank Caving			38.984010 °	38.983955 °
				-121.487420 °	-121.488083 °
DWR ID	DWR_RD1001_03_s _ 2013_38				
Action/Comments					
Schedule repair of erosion site prior to the next inspection.

Erosion caused by run off from the roadway. Spring 2013

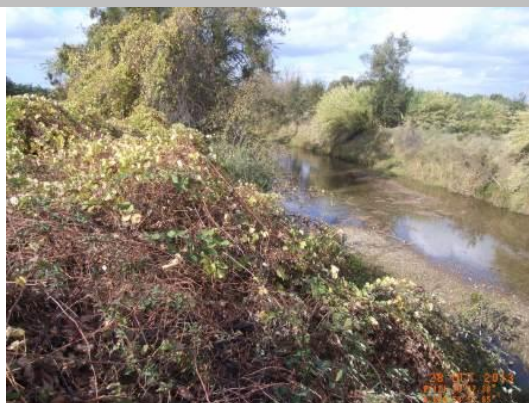
Photo 1 of 1 : SP_2015_RD1001_37_19_20150401_00011.jpg

LM Start	7.21	Rating **	M	Issue No.	19
LM End	7.30	Issue Type +	Ma	Location *	WS
Category	Supplemental			GPS Latitude/Longitude	
				Start	End
Item	USACE Erosion Survey			38.982737 °	38.982572 °
				-121.501144 °	-121.502797 °
DWR ID	DWR_RD1001_03_f _ 2014_19				
Action/Comments					
Inspector Comments: 2008 - Sandy/silty banks with rotational slab failures creating near vertical bank with pop-outs due to tree failures. Narrow berm. 2013: No observed changes. [2013 Site ID: BER_5-7_L]

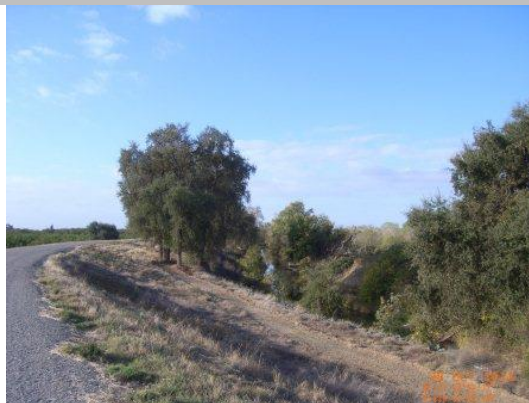
Photo 1 of 1 : SP_2015_RD1001_37_10_20150401_00008.jpg

LM Start	11.08	Rating **	M	Issue No.	10
LM End	11.16	Issue Type +	Ma	Location *	WS
Category	Supplemental			GPS Latitude/Longitude	
				Start	End
Item	USACE Erosion Survey			38.955070 °	38.954227 °
				-121.549528 °	-121.550592 °
DWR ID	DWR_RD1001_03_f_2014_10				
Action/Comments					
Inspector Comments: 2011 - Large slumped sections of bank. 2012 - Slopes slightly steeper. 2013: No observed changes. [2013 Site ID: BER_1-9_L]

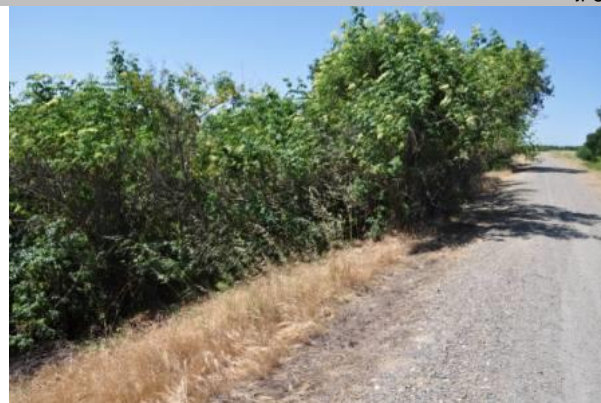
Photo 1 of 1 : SP_2015_RD1001_37_22_20150401_00014.jpg

LM Start	11.23	Rating **	M	Issue No.	22
LM End	11.26	Issue Type +	Ma	Location *	LS
Category	Earthen Levee			GPS Latitude/Longitude	
				Start	End
Item	Vegetation			38.953367 °	38.953025 °
				-121.551428 °	-121.551808 °
DWR ID	DWR_RD1001_03_s_2012_22				
Action/Comments					
Elderberries are blocking visibility and flood fight capability.

RD 1001 Unit 3 - L/S slope -Elderberries

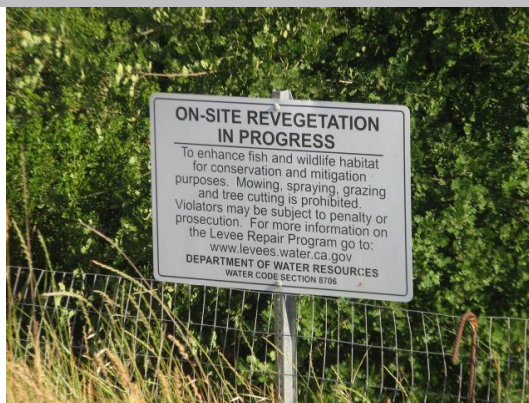
Photo 1 of 1 : SP_2015_RD1001_37_25_20150401_00015.jpg

LM Start	11.59	Rating **	A/W	Issue No.	25
LM End	11.80	Issue Type +	Ma	Location *	WS
Category	Earthen Levee			GPS Latitude/Longitude	
				Start	End
Item	Vegetation			38.951302 °	38.950960 °
				-121.556872 °	-121.560717 °
DWR ID	DWR_RD1001_03_s_2013_25				
Action/Comments					
Environmental Requirements.

Revegetation site in progress. Spring 2013

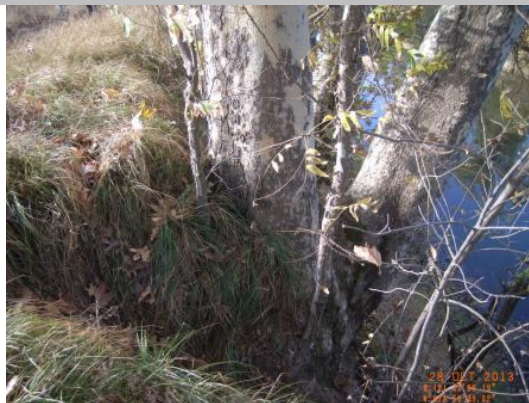
Photo 1 of 1 : SP_2015_RD1001_37_1_20150401_00001.jpg

LM Start	12.07	Rating **	M	Issue No.	1
LM End	12.16	Issue Type +	Ma	Location *	WS
Category	Supplemental			GPS Latitude/Longitude	
				Start	End
Item	USACE Erosion Survey			38.947591 °	38.946477 °
				-121.563390 °	-121.564094 °
DWR ID	DWR_RD1001_03_f_2014_1				
Action/Comments					
Inspector Comments: 2006 - Multiple rotational failures in the berm. Erosion is into the levee toe and lower slope. Tension cracks extensive at top of bank. Cohesive toe creates a bench on which failures occur. 2007 - Still steep bank with some berm with pistol-butted reeds. 2012 - Site extended upstream due to additional slumping. Slopes slightly steeper. 2013: No observed changes. [2013 Site ID: BER_0-8_L]

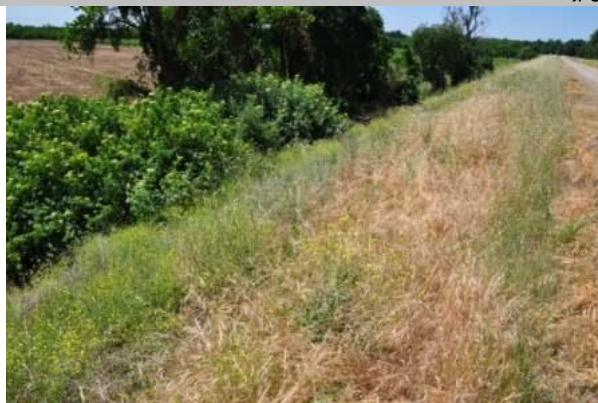
Photo 1 of 1 : SP_2015_RD1001_37_27_20150401_00016.jpg

LM Start	12.18	Rating **	M	Issue No.	27
LM End	12.18	Issue Type +	Ma	Location *	LS
Category	Earthen Levee			GPS Latitude/Longitude	
				Start	End
Item	Vegetation			38.946248 °	38.946248 °
				-121.564220 °	-121.564220 °
DWR ID	DWR_RD1001_03_s_2012_27				
Action/Comments					
Elderberries are blocking visibility and flood fight capability.

RD 1001 Unit 3 - L/S slope -Elderberries @ toe.

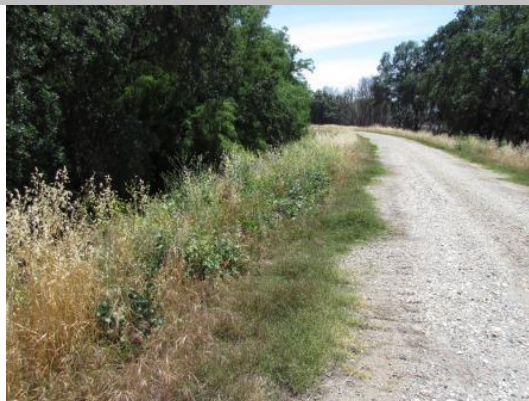
Photo 1 of 1 : SP_2015_RD1001_38_33_20150521_00037.jpg

View of the vegetation on the landside of the levee facing downstream.

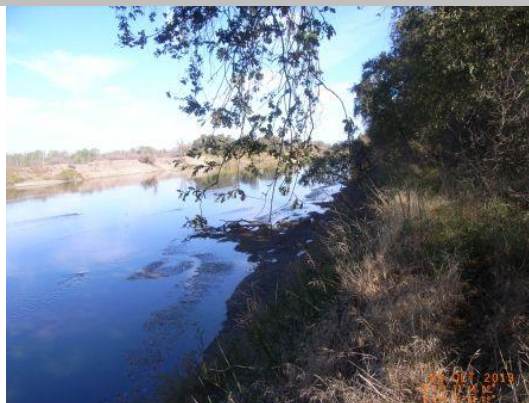
Photo 1 of 1 : SP_2015_RD1001_38_7_20150401_00007.jpg

LM Start	6.42	Rating **	M	Issue No.	7
LM End	6.51	Issue Type +	Ma	Location *	WS
Category	Supplemental			GPS Latitude/Longitude	
				Start	End
Item	USACE Erosion Survey			38.865875 °	38.864706 °
				-121.619983 °	-121.620813 °
DWR ID	DWR_RD1001_04_f_2014_7				
Action/Comments					
Inspector Comments: 2011 - Tall slumping sections. Scour around trees has exposed most of the roots. 2013: No observed changes. [2013 Site ID: FHR_6-0_L]

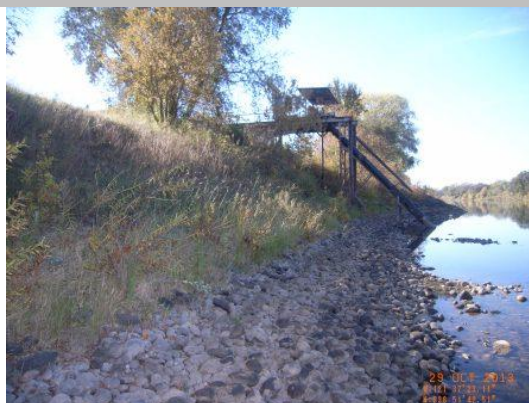
Photo 1 of 1 : SP_2015_RD1001_38_6_20150401_00006.jpg

LM Start	6.57	Rating **	M	Issue No.	6
LM End	6.77	Issue Type +	Ma	Location *	WS
Category	Supplemental			GPS Latitude/Longitude	
				Start	End
Item	USACE Erosion Survey			38.863946 °	38.861558 °
				-121.621388 °	-121.623316 °
DWR ID	DWR_RD1001_04_f_2014_6				
Action/Comments					
Inspector Comments: 2011 - Large slumped sections on the lower bank. 2012 - New cracks observed. 2013: No observed changes. [2013 Site ID: FHR_5-8_L]

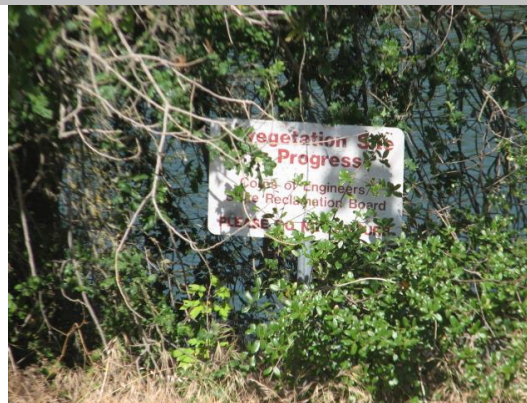
Photo 1 of 1 : SP_2015_RD1001_38_28_20150401_00024.jpg

Revegetation site. Spring 2013

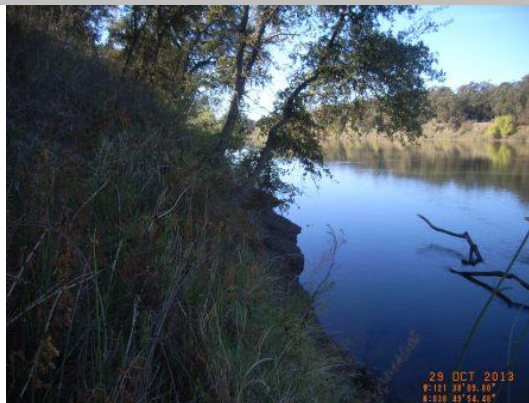
Photo 1 of 1 : SP_2015_RD1001_38_4_20150401_00004.jpg

LM Start	8.64	Rating **	M	Issue No.	4
LM End	8.97	Issue Type +	Ma	Location *	WS
Category	Supplemental			GPS Latitude/Longitude	
				Start	End
Item	USACE Erosion Survey			38.836966 °	38.831498 °
				-121.634128 °	-121.636371 °
DWR ID	DWR_RD1001_04_f_2014_4				
Action/Comments					
Inspector Comments: 2006 - Sandy, silty bank with intermittent pockets of erosion. Rotational failure and tree pop outs are most of the problem. Some upper slope fluvial erosion. 2010 - Site extended upstream. The lower Feather may benefit from a regional repair. 2011 - Site combined with 3.6. Minimal new erosion. 2013: New erosion observed at bank toe. Trees on site now have exposed roots. [2013 Site ID: FHR_3-8_L]

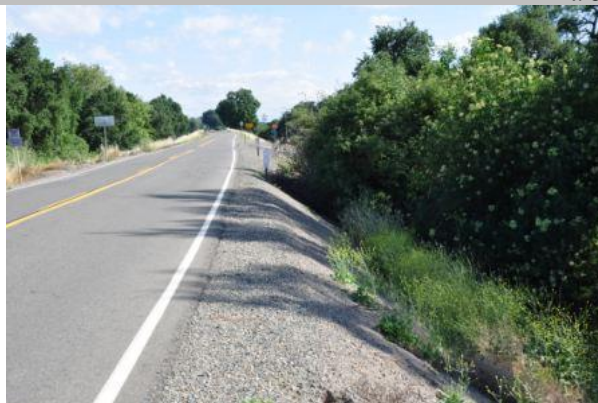
Photo 1 of 1 : SP_2015_RD1001_38_12_20150401_00010.jpg

RD 1001 Unit 4 - W/S slope - Elderberries

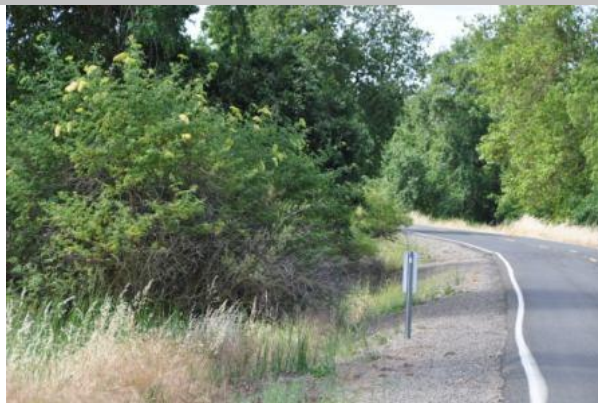
Photo 1 of 1 : SP_2015_RD1001_38_22_20150401_00017.jpg

RD 1001 Unit 4 - L/S slope - Elderberries

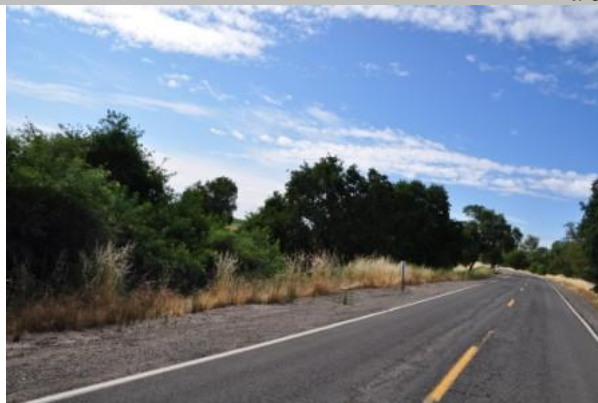
Photo 1 of 1 : SP_2015_RD1001_38_23_20150401_00018.jpg

RD 1001 Unit 4 - L/S slope - Elderberries

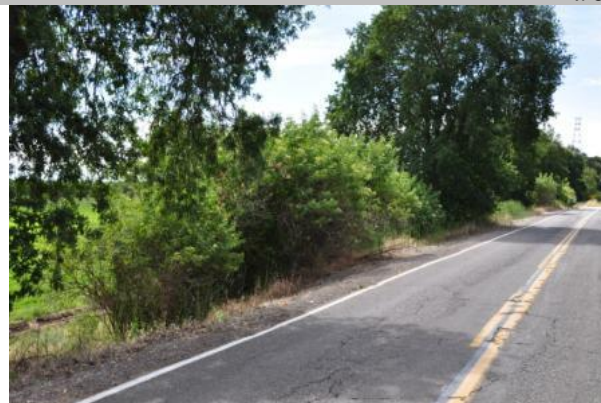
Photo 1 of 1 : SP_2015_RD1001_38_24_20150401_00019.jpg

RD 1001 Unit 4 - L/S slope - Elderberries

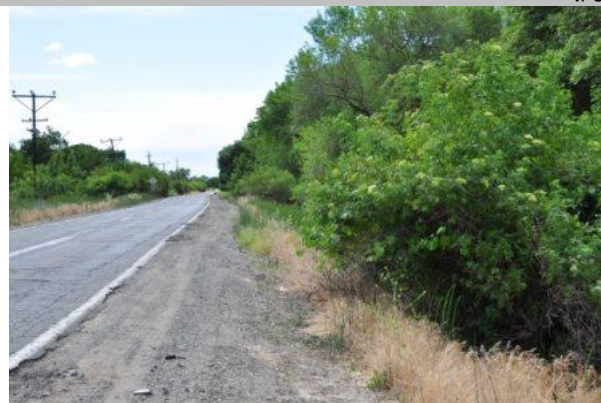
Photo 1 of 1 : SP_2015_RD1001_38_26_20150401_00022.jpg

RD 1001 Unit 4 - W/S slope - Elderberries

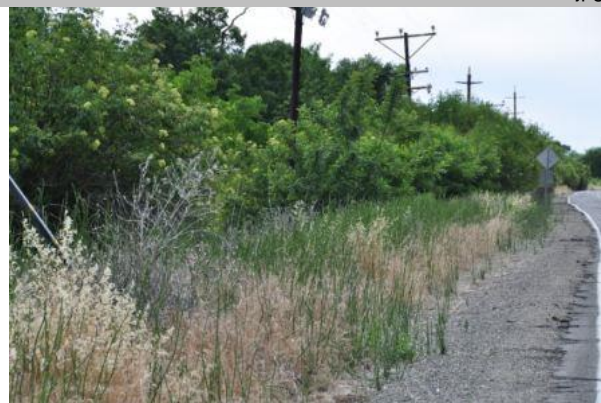
Photo 1 of 1 : SP_2015_RD1001_38_11_20150401_00009.jpg

RD 1001 Unit 4 - W/S slope - Elderberries

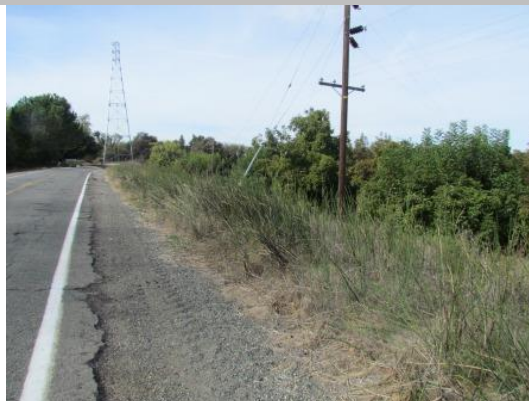
Photo 1 of 1 : SP_2015_RD1001_38_31_20150401_00027.jpg

This photo was taken from the levee crown facing north looking down the landward slope at vegetation that needs to be removed. Fall 2014.

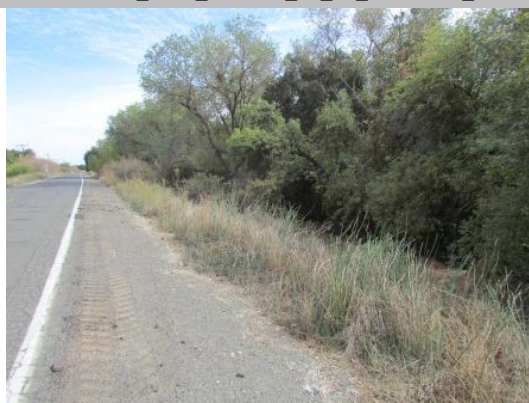
Photo 1 of 1 : SP_2015_RD1001_38_32_20150401_00028.jpg

This photo was taken from the levee crown facing south looking down the waterward slope at vegetation that needs to be removed. Fall 2014.

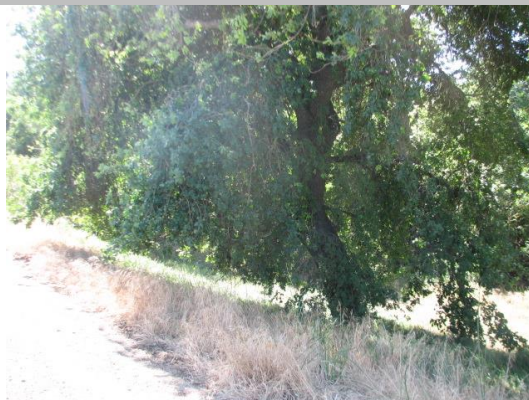
Photo 1 of 1 : SP_2015_RD1001_38_151_20150401_00031.jpg

Trees need to be trimmed up at least 5 feet. Spring 2013

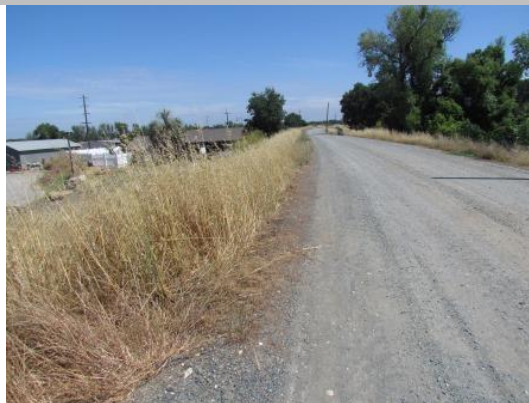
Photo 1 of 1 : SP_2015_RD1001_39_16_20150521_00018.jpg

View of the vegetation on the landside of the levee facing upstream.

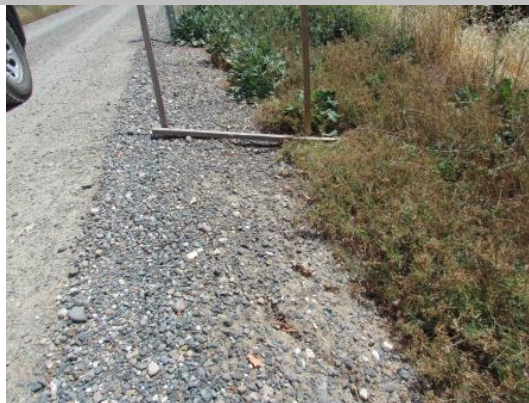
Photo 1 of 1 : SP_2015_RD1001_39_18_20150521_00019.jpg

View of the cracks from erosion on the waterside of the levee facing upstream.

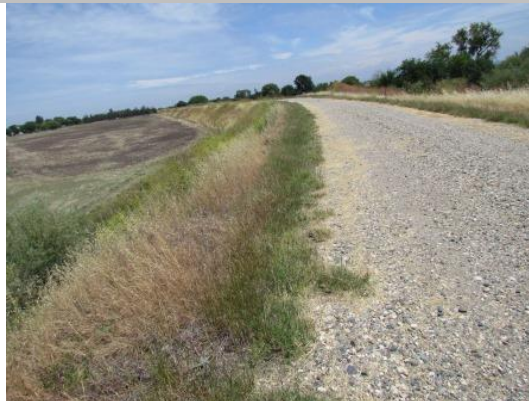
Photo 1 of 1 : SP_2015_RD1001_40_15_20150521_00015.jpg

View of the vegetation on the landside of the levee facing upstream.

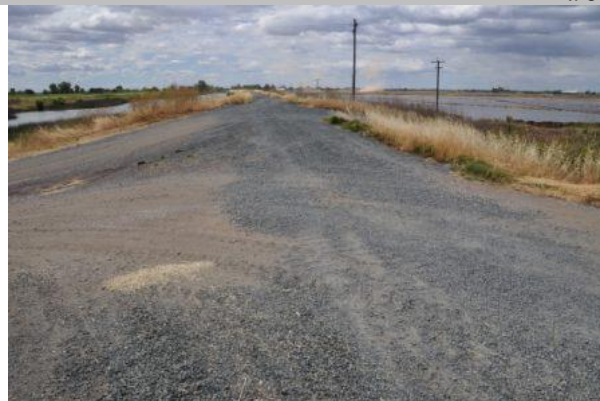
Photo 1 of 1 : SP_2015_RD1001_40_8_20150401_00005.jpg

RD 1001 Unit 6 - Levee Crown - Subsidence due to vehicle traffic.

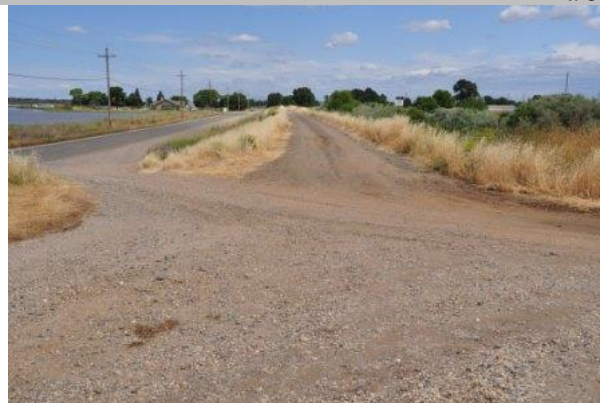
Photo 1 of 1 : SP_2015_RD1001_40_7_20150401_00004.jpg

RD 1001 Unit 6 - Levee Crown - Subsidence due to vehicle traffic.

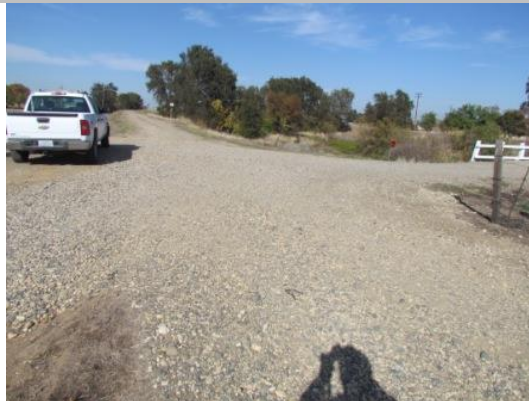
Photo 1 of 1 : SP_2015_RD1001_40_19_20150401_00006.jpg

This photo was taken from the levee crown facing north looking at subsidence due to vehicle traffic across crown. Fall 2013.
